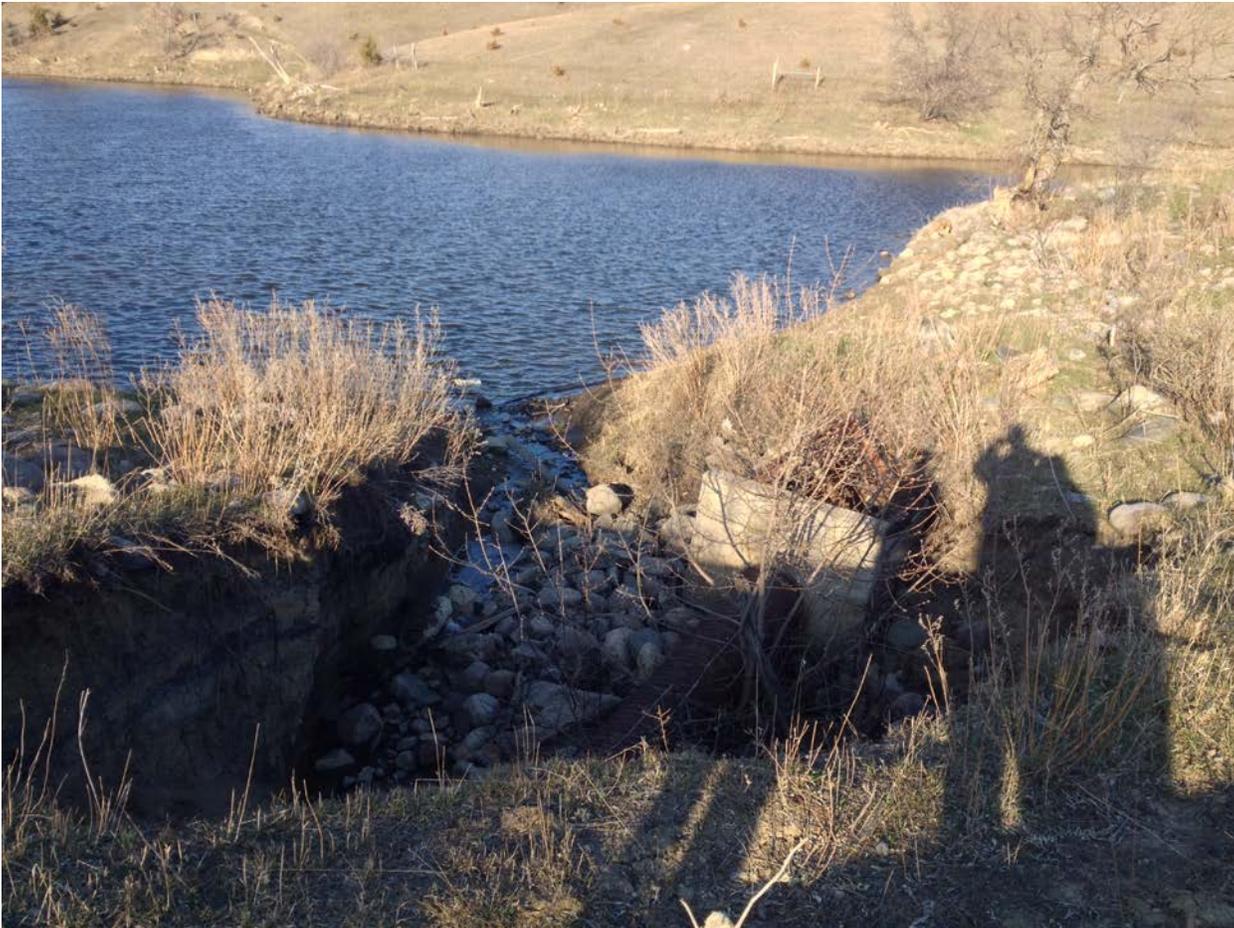
Erosion  
around  
principal  
spillway inlet  
structure and  
dam

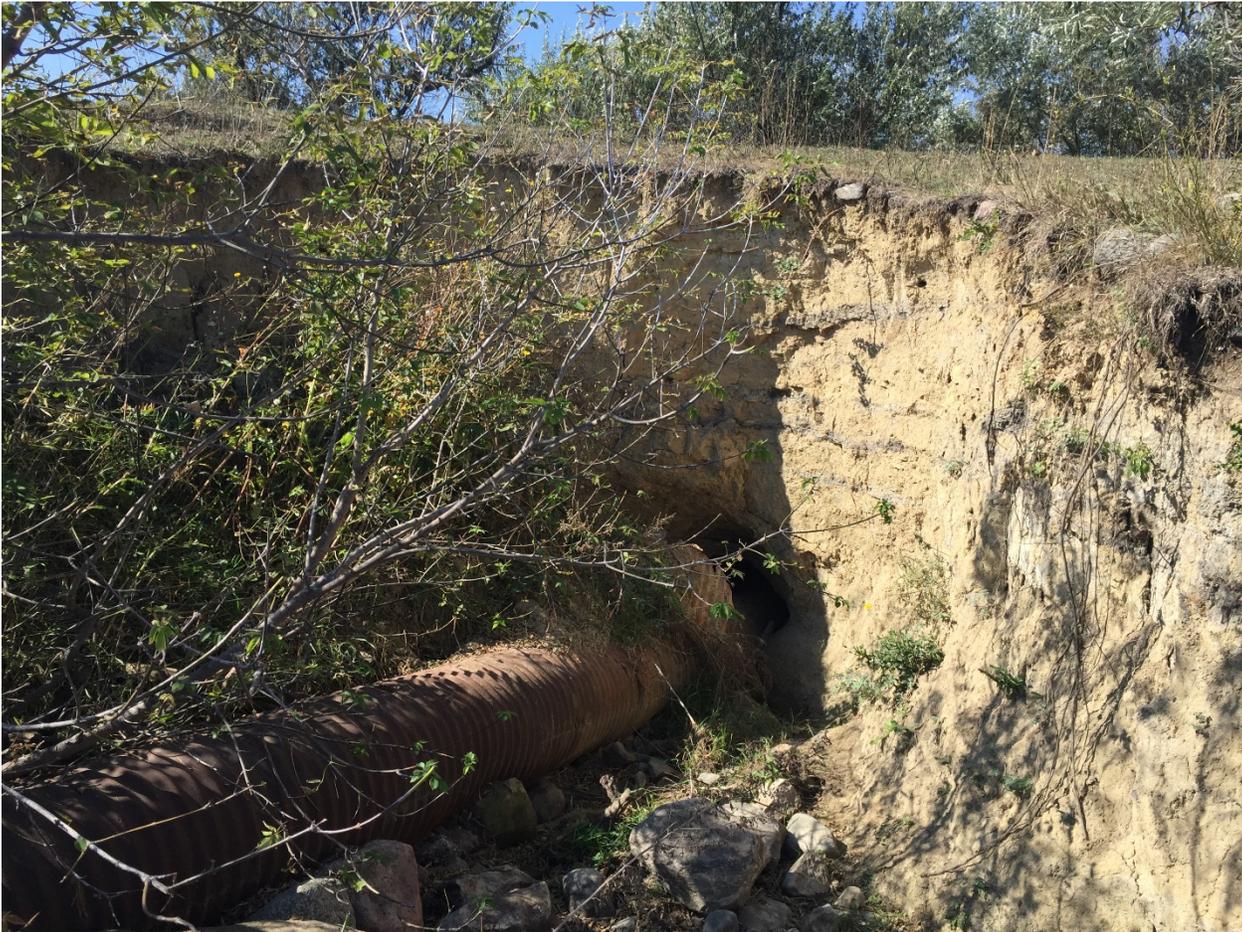
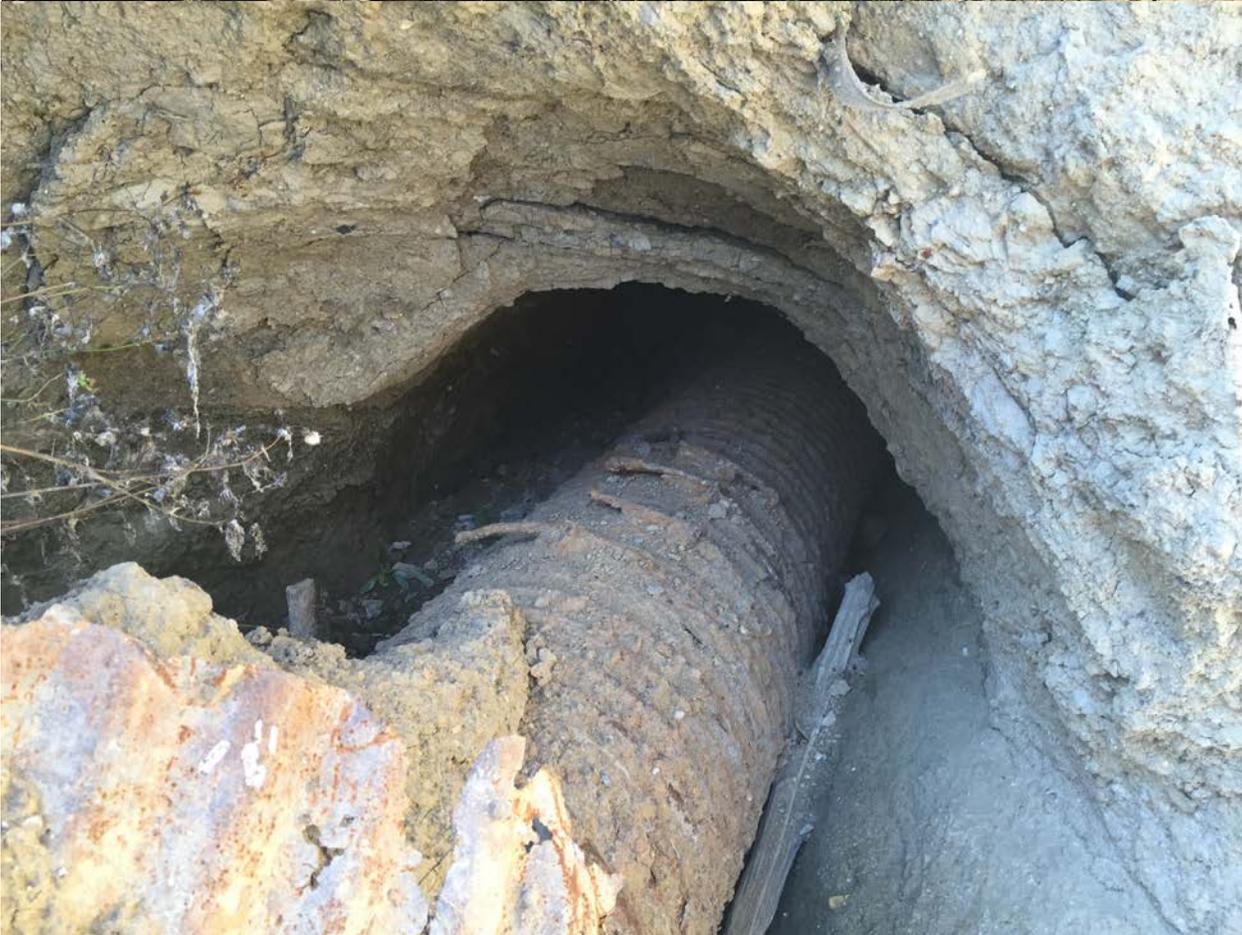
Erosion worsened through the spring and summer of 2015. In Septmeber the principal spillway had worsened to the point that replacement was absolulty required prior to spring runoff of 2016.

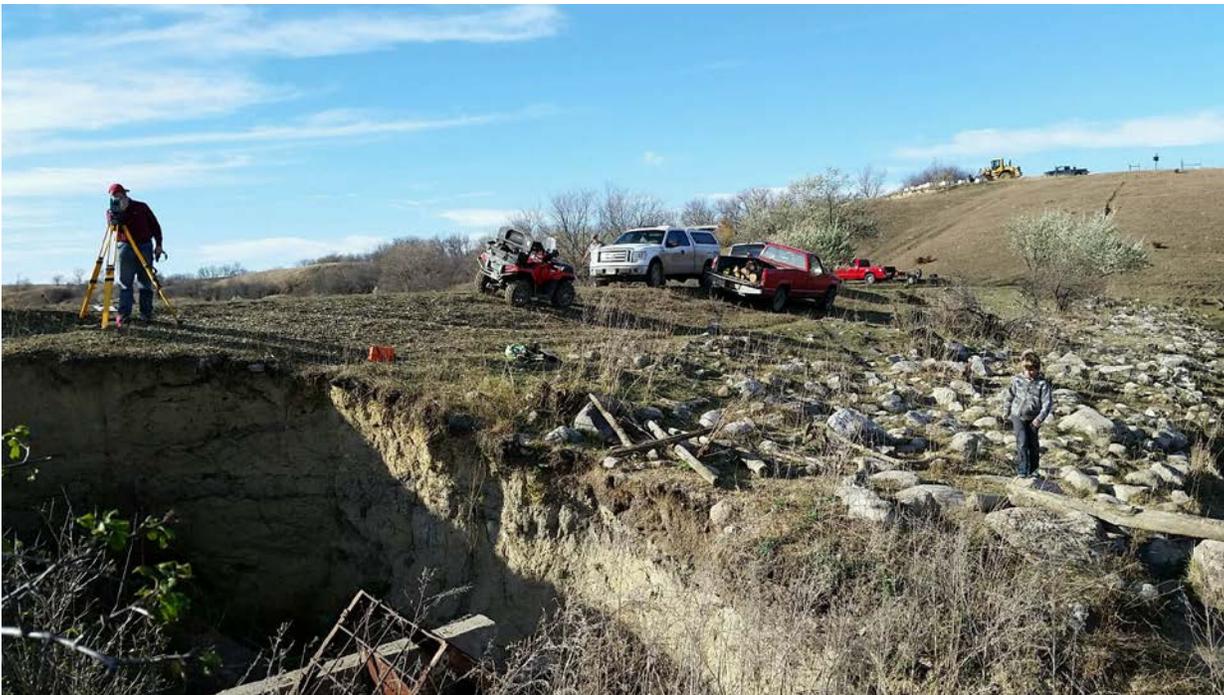
Fingal Wildlife Club members performed the construction survey and staking for the contractor to establish a similar line and grade to the existing principal spillway inlet and pipe.

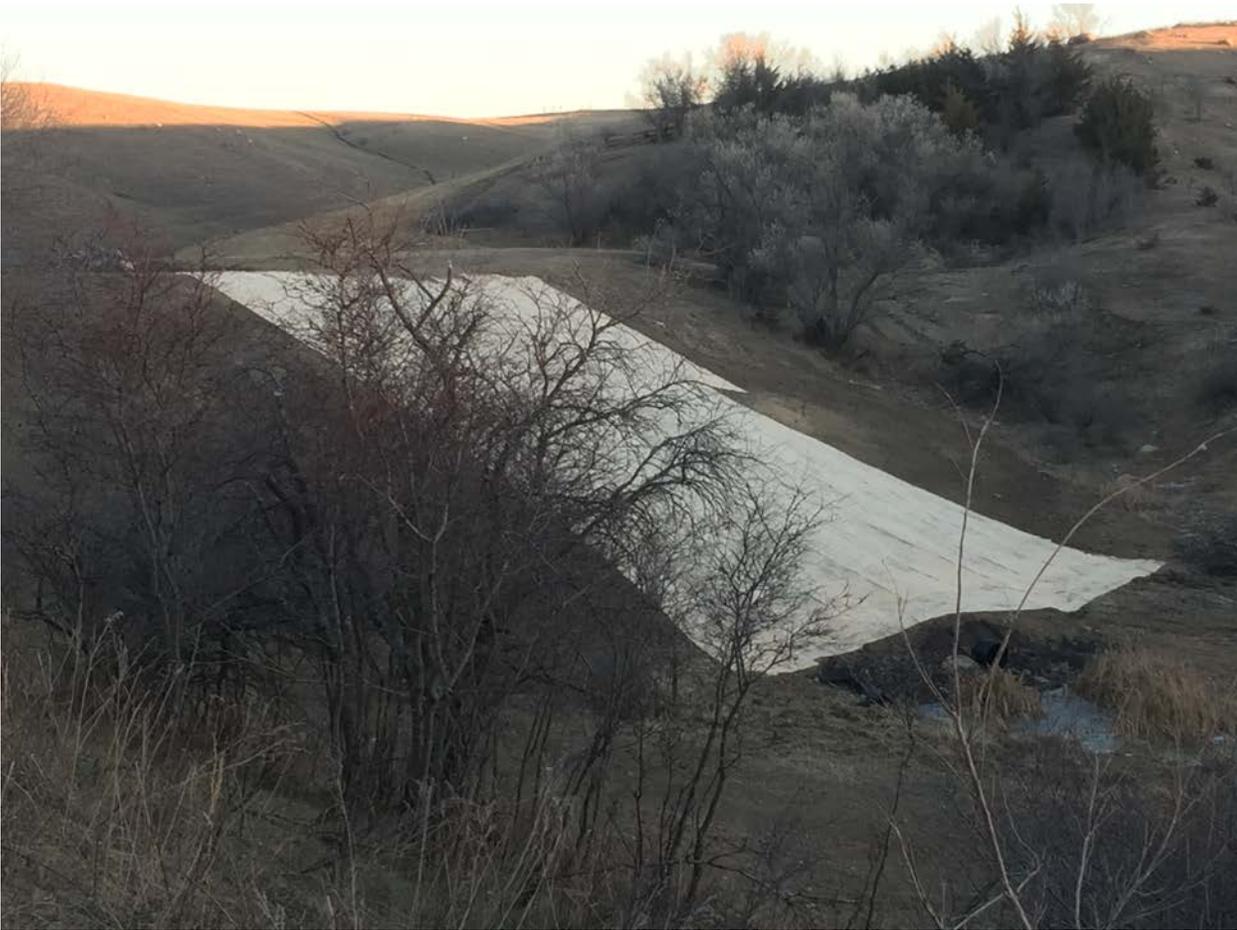
Completed  
project as of  
11/20/2015.
